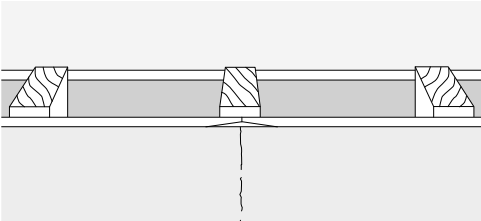
Blisters in Tape	
<p>Description</p> <ul style="list-style-type: none"> – Bubbles appear in areas of the paper jointing tape (ranging in size from approximately 10mm to 40mm, or more) 	<p>Remedy</p> <ul style="list-style-type: none"> – Slit tape to open up blistered area – Fill out with compound, then press tape back in place with broad-knife – When dry, smooth to level finish
<p>Cause</p> <ul style="list-style-type: none"> – Insufficient compound used under tape – Tape not initially pressed into good contact with compound – Too much compound forced from under tape by excessive tool pressure when embedding – Not enough compound in recess – Compound gauge is too dry 	<p>Prevention</p> <ul style="list-style-type: none"> – Provide sufficient compound under entire tape – 0.8mm
Centre Cracking	
<p>Description</p> <ul style="list-style-type: none"> – Cracks appear in the joint down the centre of the joint tape

<p>Remedy</p> <p>Relieve stress, i.e. providing adequate isolation by installing a control joint and re-taping, then feathering compound over broad area to disguise build-up</p>

<p>Cause</p> <ul style="list-style-type: none"> – Abnormal stress build-up resulting from structural deflection or racking – Excessive stresses resulting from hygrometric and/or thermal expansion and contraction 	<p>Prevention</p> <ul style="list-style-type: none"> – Correct unsatisfactory environmental conditions – Provide sufficient relief and re-tape – Provide proper isolation from structure to prevent stress build-up – Provide adequate control joints – Structurally brace underlying framing – Ensure moisture content of timber is 18% or less
